Documentation Analysis of Berth 15 to 17A
at East Wharf,
Karachi Port Trust.

Karachi Port Trust - Berth 15 to 17A at East Wharf – Technical Report

Project: Documentation Analysis of Berth 15 to 17A East Wharf

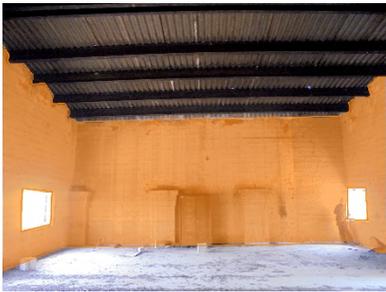
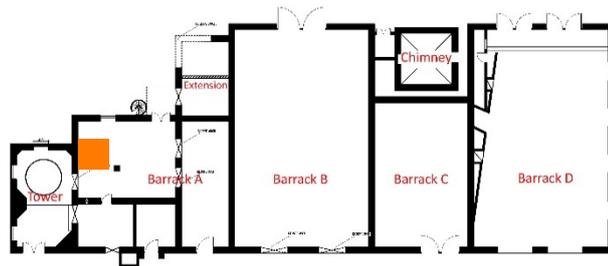
Figure 33 - Paint over Surface - Barrack A, 15 to 17A, East Wharf, KPT, Karachi.

Figure 34 – Plan - Paint over Surface - Barrack A, 15 to 17A, East Wharf, KPT, Karachi.

The interior stone surface of Barrack A has been painted white.

After careful restoration of the structures through a chosen option, measures will be taken in order to conserve the heritage from further damage and destruction. The encroachments on the original structures would be removed. Such as the extension on Barrack A and concrete encroachment on Barrack B. The windows of the mosque (Barrack D) would also be brought down as they are not part of the original openings. Additive concrete would all be removed. Stone will then be cleaned by washing, brushing, and pointing which should be done with lime. Wooden trusses will be cleaned and termite-proofed, provided that their structural integrity is intact. Red Oxide will be sprayed on iron and steel to prevent rusting.

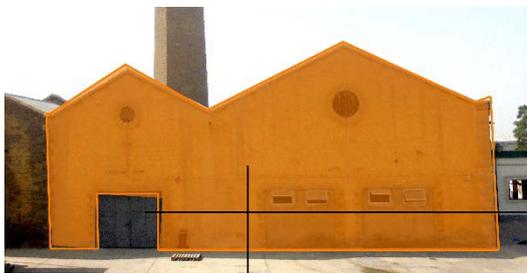
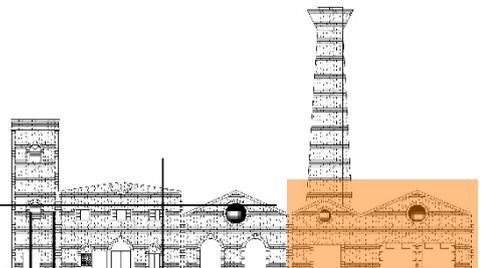
Figure 35 - Paint over Surface - Barrack C and D, 15 to 17A, East Wharf, KPT, Karachi.

Figure 36 – South-East Elevation - Paint over Surface - Barrack C and D, 15 to 17A, East Wharf, KPT, Karachi.

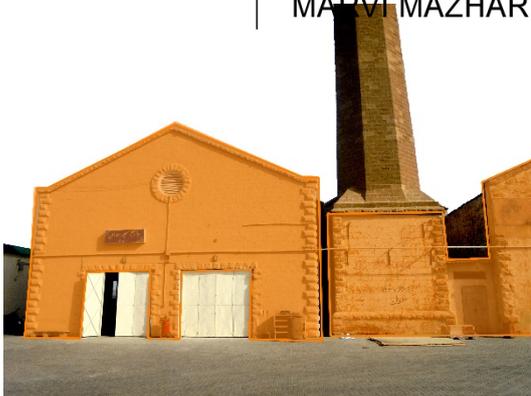
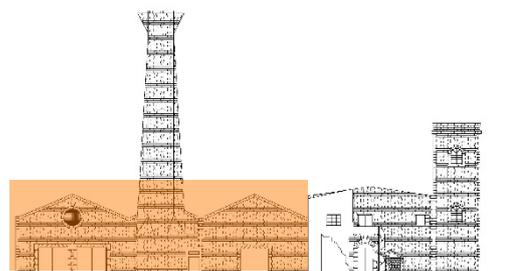
Figure 37 - Paint over Surface - Barrack D, base of Chimney Tower, Extension, and Barrack B, 15 to 17A, East Wharf, KPT, Karachi, Pakistan

Figure 38 – North West Elevation - Paint over Surface - Barrack D, base of Chimney Tower, Extension, and Barrack C, 15 to 17A, East Wharf, KPT, Karachi, Pakistan.

The exterior elevation on the North-west side of Barrack D, base of Chimney Tower, extension next to it and the north-west façade of Barrack B has been painted.

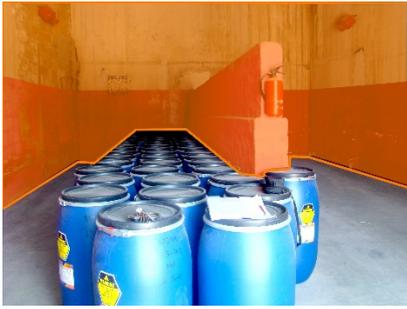
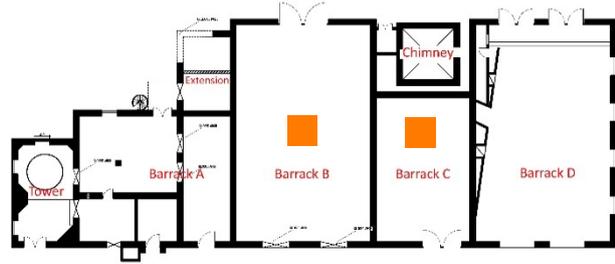
Figure 39 - Interior walls of barrack B and C painted.

Figure 40 - Interior walls of barrack B and C painted.

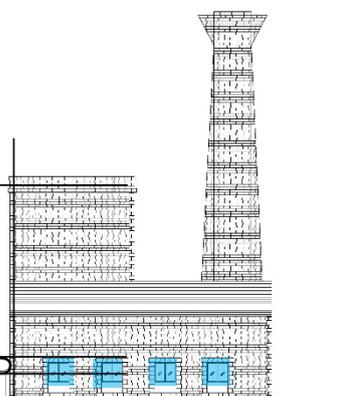
Figure 42 – Concrete - Barrack D, North – East Elevation.

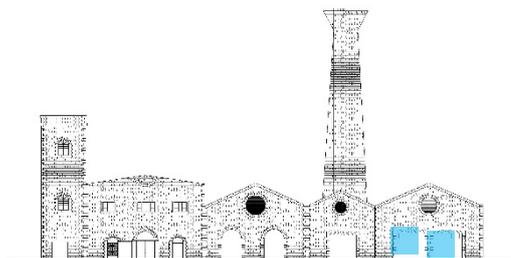
Figure 44 - Concrete - South-east elevation, openings on Barrack D, 15 to 17A, East Wharf, KPT, Karachi.

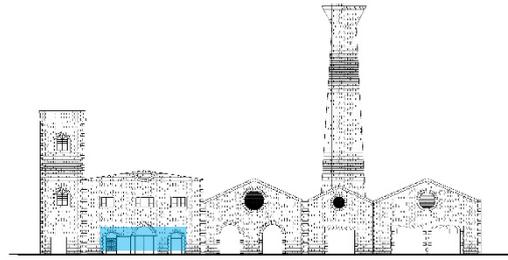
Figure 46 - Concrete encroachment on Barrack A, South-east elevation, near doors, arched openings, and openings made on the added level.

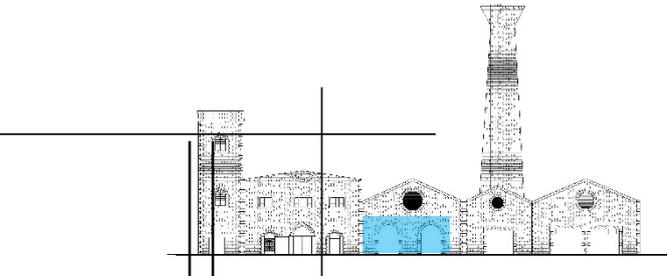
Figure 48 - Concrete - arched openings, Barrack B, south-east elevation, 15 to 17A East wharf, KPT, Karachi.

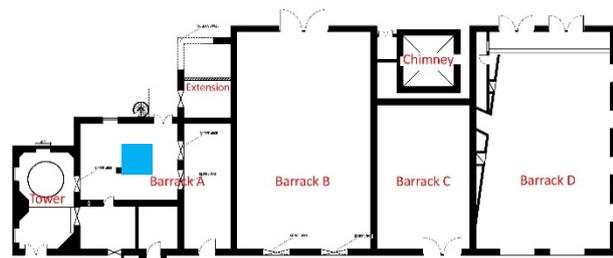
Figure 50 - Concrete - Interior of Barrack A, 15 to 17A East Wharf, KPT, Karachi.

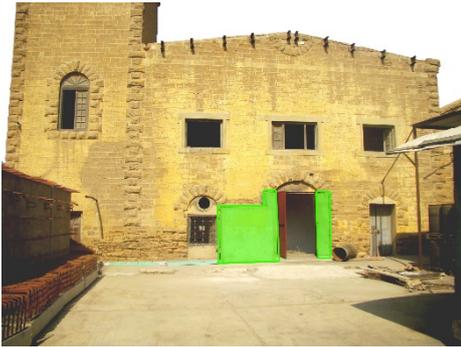
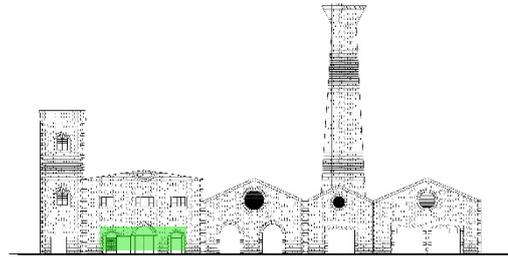
Figure 61 - Encroachment - South-east Facade, Barrack A, 15 to 17A, East Wharf, KPT, Karachi.

Figure 52 - Encroachment - South-east Facade, Barrack A, 15 to 17A, East Wharf, KPT, Karachi.

Encroachments in the form of concrete extension is present on the south-east façade of Barrack A.

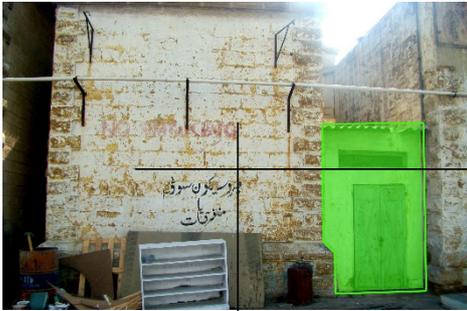
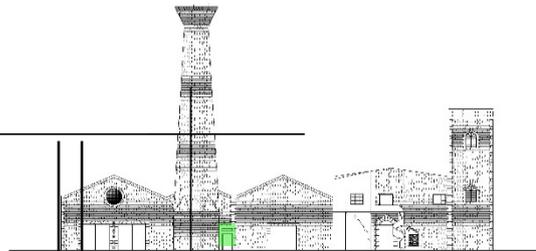
Figure 53 - Encroachment - North-west Facade, between Chimney Tower and Barrack B, 15 to 17A, East Wharf, KPT, Karachi.

Figure 54 - Encroachment - North-west Facade, between Chimney Tower and Barrack B, 15 to 17A, East Wharf, KPT, Karachi.

A store has been built on the space between the Chimney and Barrack B on the north-west side. This is an encroachment and should be removed.

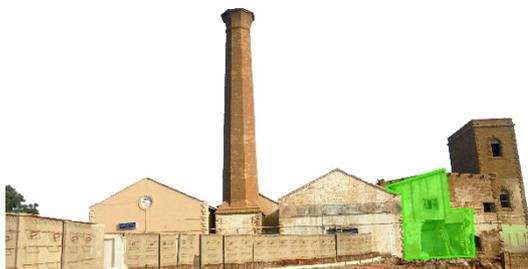
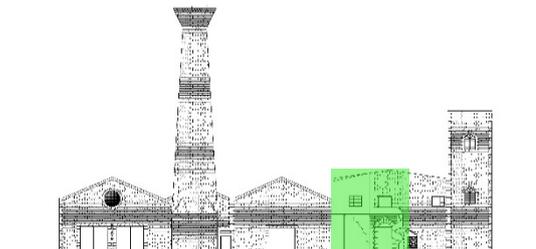
Figure 55 - Encroachment - North-west Facade, extension Barrack A, 15 to 17A, East Wharf, KPT, Karachi.

Figure 56 - Encroachment - North-west Facade, extension Barrack A, 15 to 17A, East Wharf, KPT, Karachi.

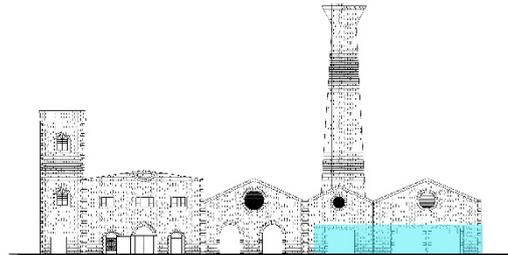
Figure 58 - Later Addition - openings, south-east facade, Barrack C and D, 15 to 17A, East Wharf, KPT, Karachi.

Square openings on the south-east façade of Barrack C has been closed by an iron door and the two openings on Barrack D have been covered with concrete. Both of these interventions have been done much later and are not a part of the original structure.

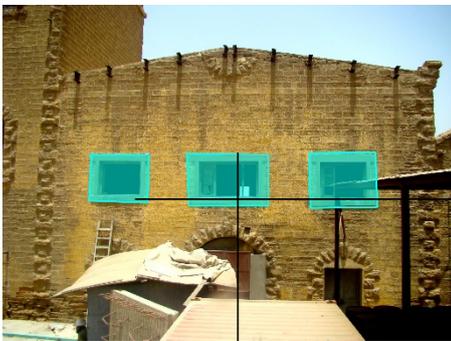
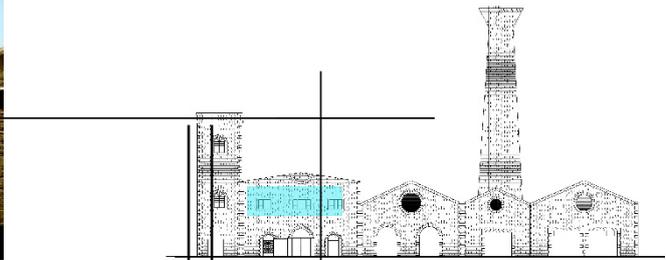
Figure 59 - Later Addition, openings on Barrack A, south-east facade, 15 to 17A, East Wharf, KPT, Karachi.

Figure 60 - Later Addition, openings on Barrack A, south-east facade, 15 to 17A, East Wharf, KPT, Karachi.

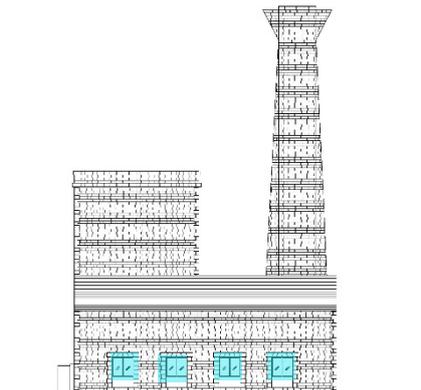
Figure 62 - Later Addition, opening on north-east facade, Barrack D, 15 to 17A, East Wharf, KPT, Karachi.

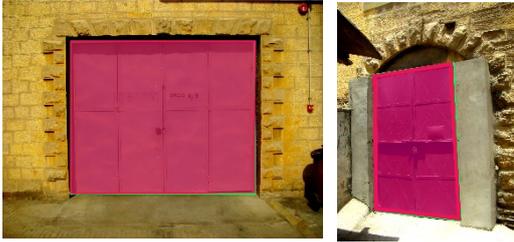
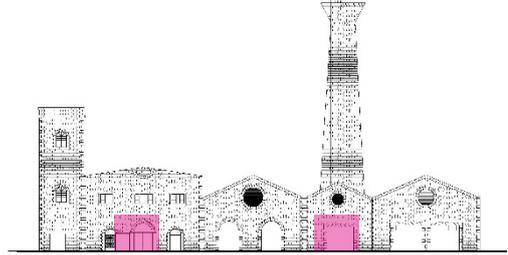
Figure 63 - Prone to rust - Iron door, barrack C, south-east facade, 15 to 17A, East Wharf, KPT, Karachi.

Figure 64 - Prone to rust - Iron door, barrack C, south-east facade, 15 to 17A, East Wharf, KPT, Karachi.

Iron door on Barrack C and on barrack A, south-east side, are prone to rust.

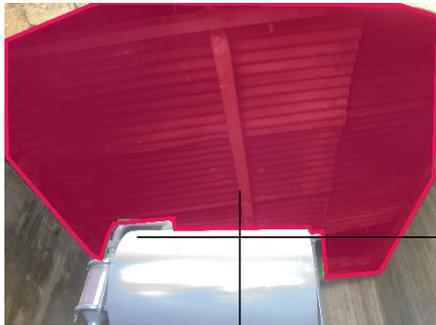
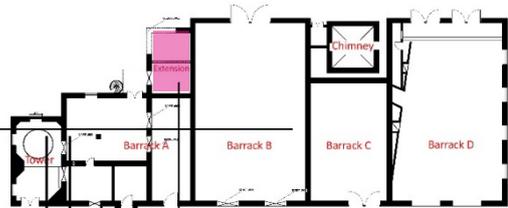
Figure 65 - Prone to Rust, Roof Structure, Extension, Barrack A, 15 to 17A, East Wharf, KPT, Karachi.

Figure 66 - Plan - Prone to Rust, Roof Structure, Extension, Barrack A, 15 to 17A, East Wharf, KPT, Karachi.

Roof of extension built alongside Barrack A and B has iron beams and girders used. These have caught rust overtime and would need immediate treatment.

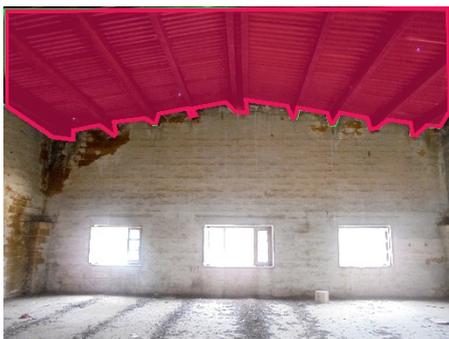
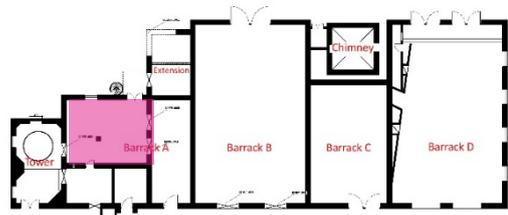
Figure 67 - Prone to rust, Roof structure, Barrack A, 15 to 17A, East Wharf, KPT, Karachi.

Figure 68 - Prone to rust, Roof structure, Barrack A, 15 to 17A, East Wharf, KPT, Karachi.

Iron girders and beams used in the roof structure of the barracks is prone to rust.

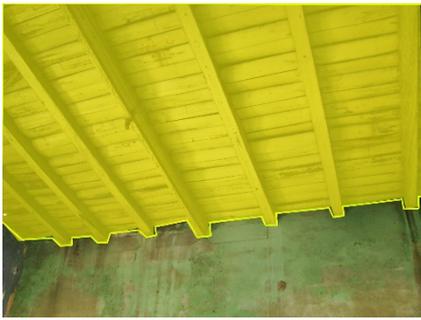
Figure 69 - Termite Infestation - Roof, Extension, first floor, Barrack A, 15 to 17A, East Wharf, KPT, Karachi.

Wooden roof used in the extension part of Barrack A might be infested with termite, therefore action must be taken against it.

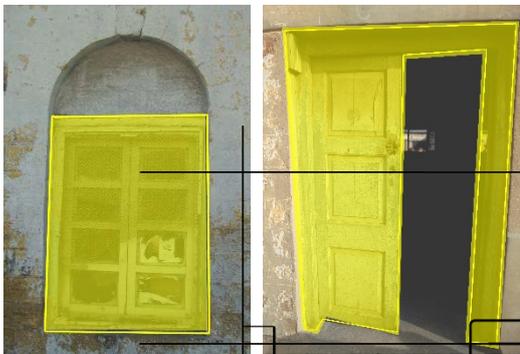
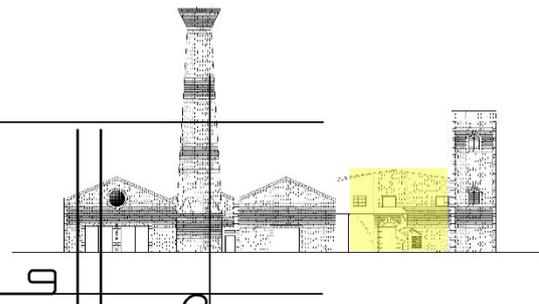
Figure 71 - Termite Infestation - Wooden doors, windows on Barrack A and its extension, East Wharf, KPT, Karachi.

Figure 72 - Termite Infestation - Wooden doors, windows on Barrack A and its extension, North-west Elevation, 15 to 17A, East Wharf, KPT, Karachi.

All the wooden doors and windows might have been infested with termite over-time and proper measures would need to be taken to determine if they can be used or replaced.

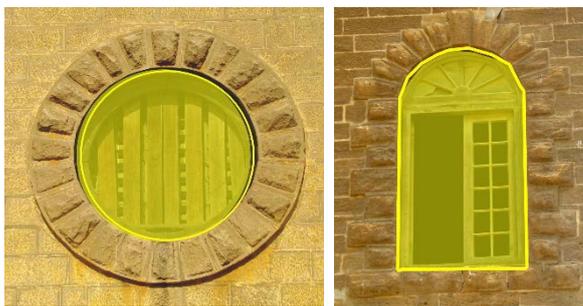
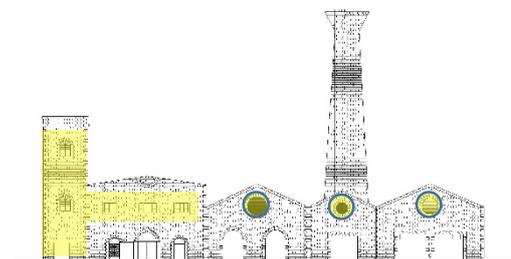
Figure 83 - Termite Infestation - Fenestration, Windows and Doors, South-east Elevation, Tower, Barrack A, B, C and D, 15 to 17 A, East Wharf, KPT, Karachi

Figure 84 - Termite Infestation - Fenestration, Windows and Doors, South-east Elevation, Tower, Barrack A, B, C and D, 15 to 17 A, East Wharf, KPT, Karachi
