Date 17/10/2016

J.M.B GIRLS SEONDARY SCHOOL (SITA RAM BUILDING)

Project: Documentation and Restoration

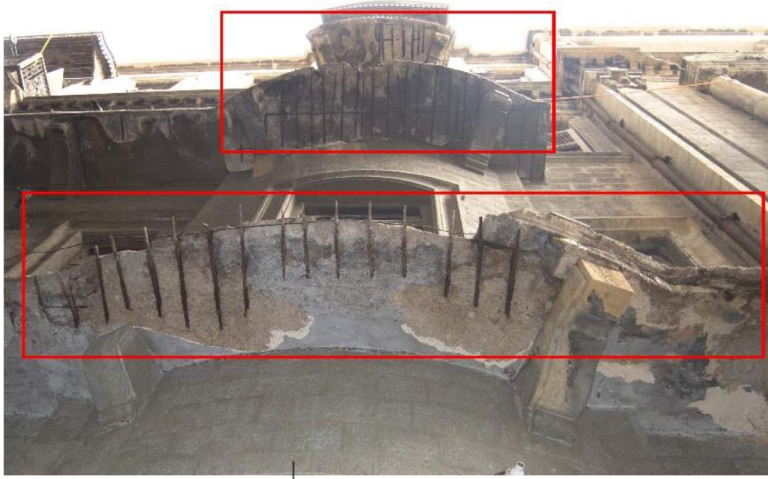
Figure 8-Existing part of the facade in dilapidated condition

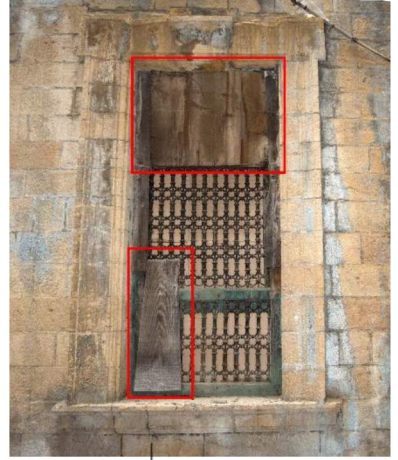
Figure 9-Existing damaged window

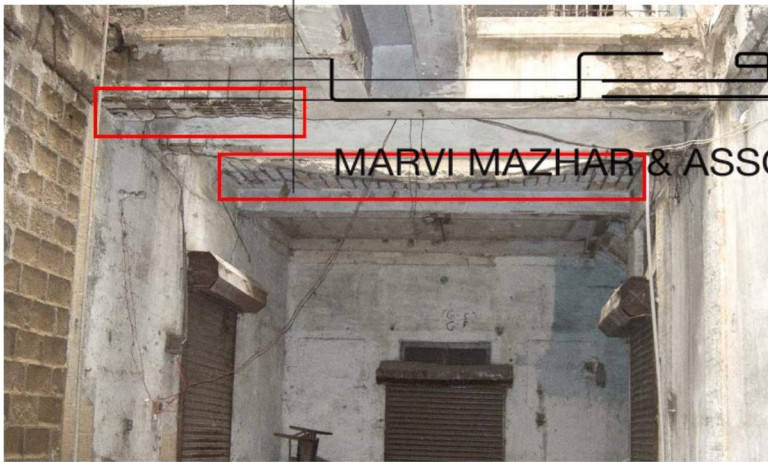
Figure 10-Existing part of the building in dilapidated condition

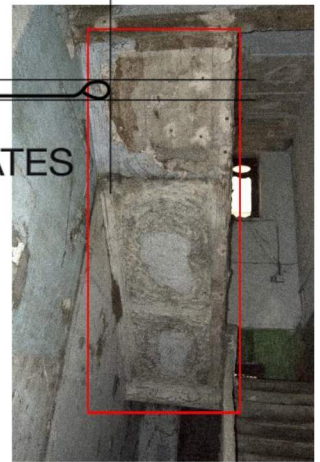
Figure 11-Existing deteriorating staircase

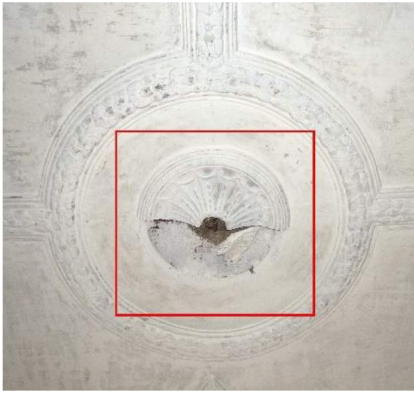
Figure 12-Existing damaged decoration of the ceiling

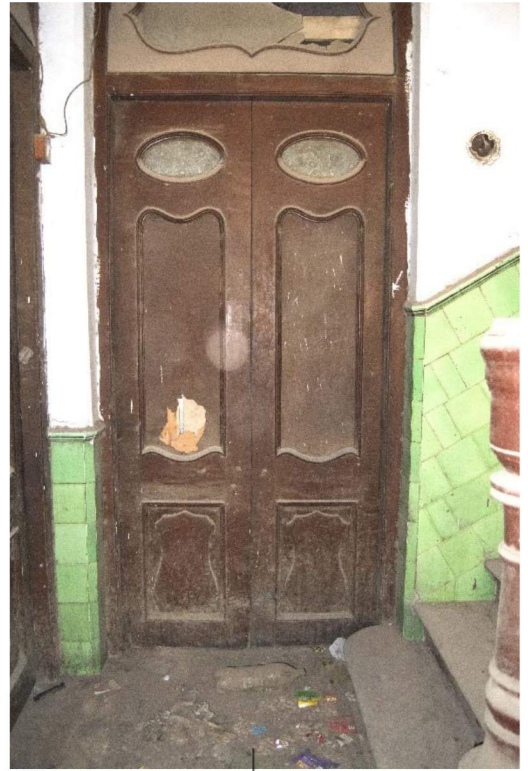
Figure 14-Existing damaged door

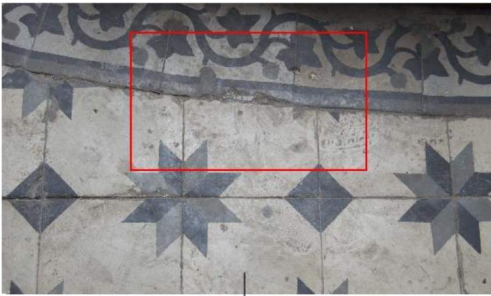
Figure 13-Existing chipped floor tiles

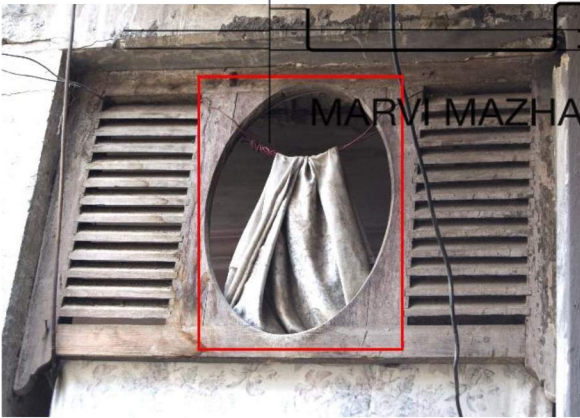
Figure 15-Glass absent in the existing ventilators

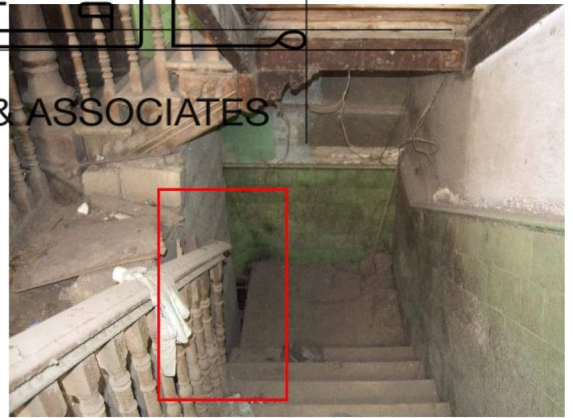
Figure 16-Damaged railings of the existing staircase

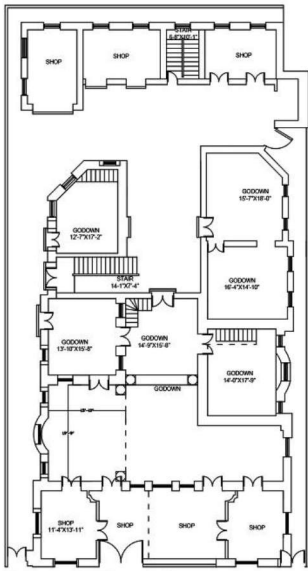
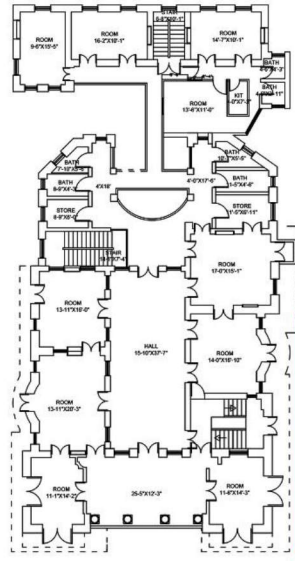
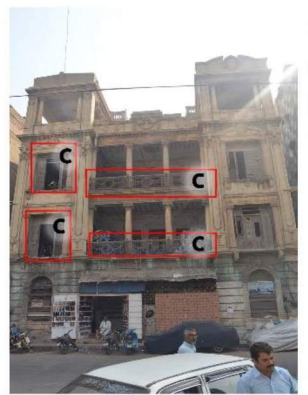
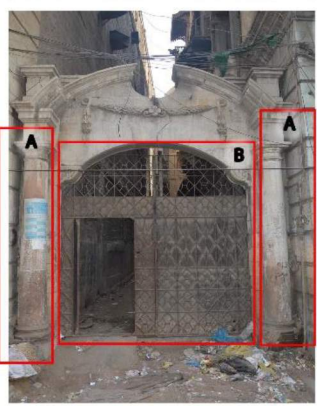
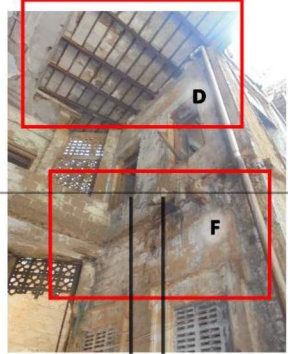
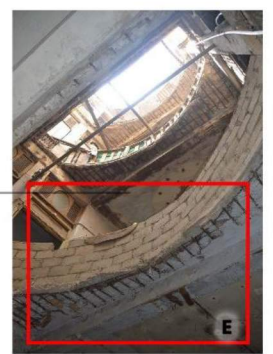
S.NO	ELEMENT	CONDITION	CAUSE
A	Column(Capital&Base)	Stone Deterioration & Discoloration	Weathering or exposure to Extreme Climatic Conditions
B	Door	Corrosion and Rusting	Weathering or exposure to Extreme Climatic Conditions
C	Parapet	Dismantled/vandalized or cracking visible on parts	Building Mafia, Roof Structure Stress, Weathering
D	Roof	Structural Damage	Weathering or exposure to Extreme Climatic Conditions
E	Slab	Structural Damage	Weathering or exposure to Extreme Climatic Conditions
F	Wall	Uneven surface of bonding plaster and discoloration	Weathering or exposure to Extreme Climatic Conditions
G	Window	Bio deterioration & Physical Alteration	Weathering or exposure to Extreme Climatic Conditions

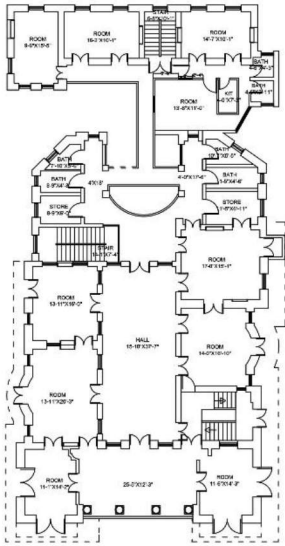
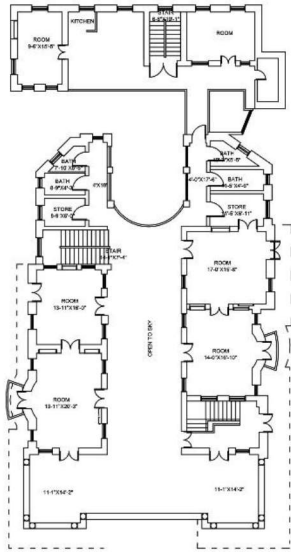
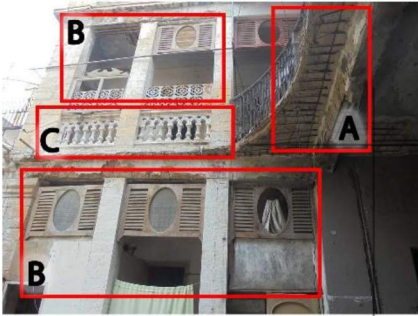
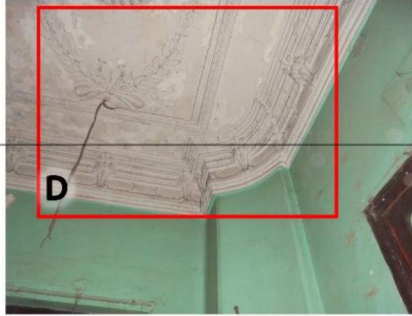
S.NO	ELEMENT	CONDITION	CAUSE
A	Slab	Structural Damage	Weathering or exposure to Extreme Climatic Conditions
B	Window	Biodeterioration & Physical Alteration	Weathering or exposure to Extreme Climatic Conditions
C	Parapet	Cracking and discoloration visible on parts	Weathering or exposure to Extreme Climatic Conditions
D	Ceiling	Discoloration & Biodeterioration & Cracking	Fluctuations in relative humidity, structural stresses and weathering.
E	Column(Capita & Base)	Stone Deterioration & Discoloration	Weathering or exposure to Extreme Climatic Conditions
F	Door	Biodeterioration & Physical Alteration	Weathering or exposure to Extreme Climatic Conditions
G	Flooring	Discoloration and cracking	Structural stress, thermal expansion, weathering
H	Staircase	Biodeterioration, structural damage and physical alterations	Vibrations/movements, thermal expansion and Weathering.
