Documentation Analysis of Berth 15 to 17A
at East Wharf,
Karachi Port Trust.

Karachi Port Trust - Berth 15 to 17A at East Wharf – Technical Report

Project: Documentation Analysis of Berth 15 to 17A East Wharf

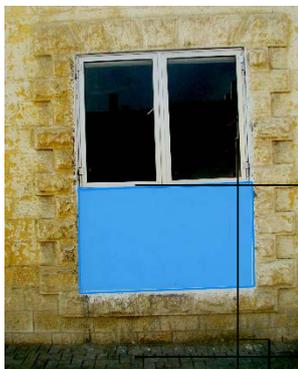
Figure 41 – Concrete - Openings on Barrack D, North – East Elevation.

Openings on the north-east elevation of Barrack D have been filled with concrete and converted into windows.

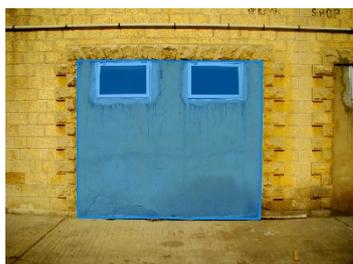
Figure 43 - Concrete - South-east elevation, openings on Barrack D, 15 to 17A, East Wharf, KPT, Karachi.

Openings on the south-east elevation of Barrack D have been covered with concrete with two ventilating window added on each of the two openings.

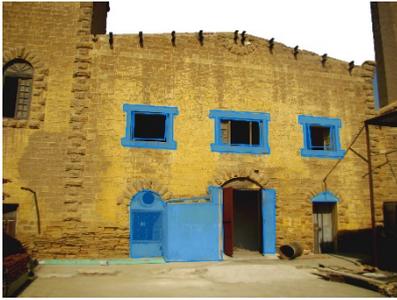
Figure 45 - Concrete encroachment on Barrack A, South-east elevation, near doors, arched openings, and openings made on the added level.

Three openings have been made on the upper level (later addition) of Barrack A. Arched openings on the ground level have been covered with concrete and converted into half openings. Concrete encroachment and pillars on either side of the central arched opening are all later interventions and will be removed.

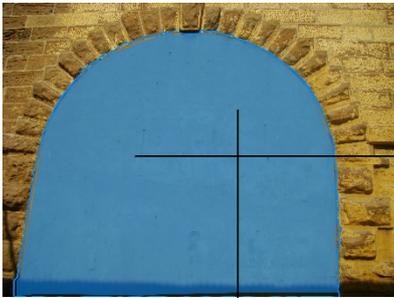
Figure 47 - Concrete - arched openings, Barrack B, south-east elevation, 15 to 17A East wharf, KPT, Karachi.

Two arched openings on the south-east façade of Barrack B have been completely filled with concrete and closed off.

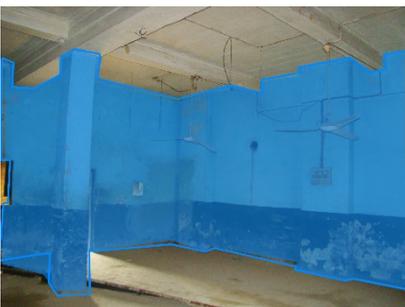
Figure 49 - Concrete - Interior of Barrack A, 15 to 17A East Wharf, KPT, Karachi.

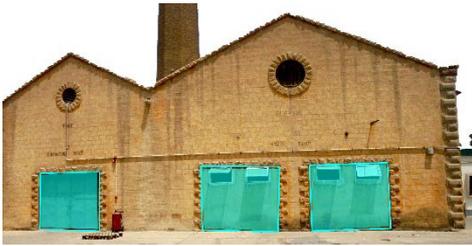
Figure 57 - Later Addition - openings, south-east facade, Barrack C and D, 15 to 17A, East Wharf, KPT, Karachi.

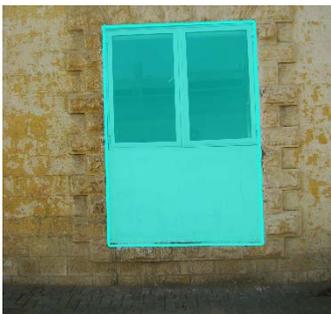
Figure 61 - Later Addition, opening on north-east facade, Barrack D, 15 to 17A, East Wharf, KPT, Karachi.

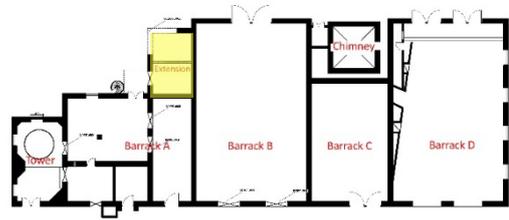
Figure 70 - Termite Infestation - Roof, Extension, first floor, Barrack A, 15 to 17A, East Wharf, KPT, Karachi.

Wooden roof used in the extension part of Barrack A might be infested with termite, therefore action must be taken against it.
